Diagnostic Interpretation of Glass Failure

Summary

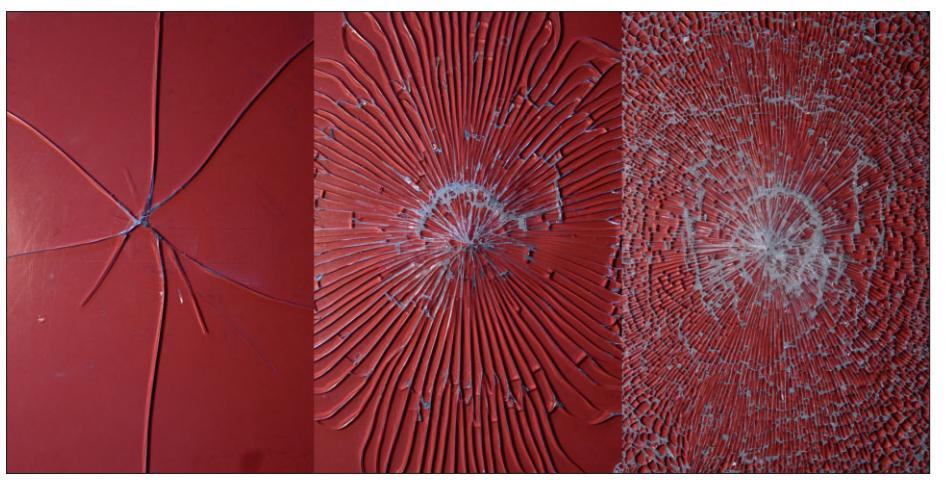
The fracture pattern is influenced by the magnitude of the surface stress induced by the heat treatment (Fig. 2). Annealed glass has no surface precompression and therefore fails at low levels of stress into large sharp shards which can cause serious injury. Fully tempered glass has the highest surface pre-compression and breaks at high levels of stress into small relatively harmless dice of about 1 cm². The fracture of heat-strengthened glass occurs somewhere between the former two and the fracture pattern is similar to that of annealed glass, i.e. relatively large sharp shards, albeit with a smaller fragment size.

Fig. 2: Images of annealed glass failure (left), heat-strengthened glass failure (centre), and fully tempered glass failure (right) [8]

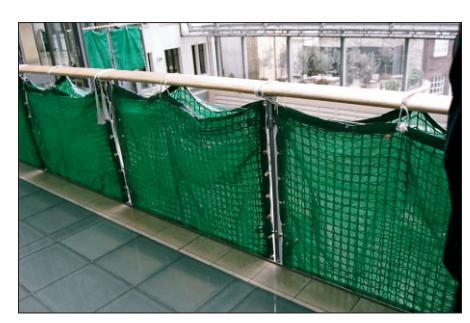
Two of the panels forming the balustrade of a pedestrian bridge within a building had failed. The glass panels consisted of monolithic fully tempered glass and measured approximately 1665 mm (width) by 1524 mm (height). They were connected to the vertical stainless steel balusters by means of three 32-mm diameter bolted fixings on each side of the glass panel. The bolted fixings were located at 75 mm from the vertical edge of the glass.

On visiting the site, two major problems were apparent. First, there was no physical evidence (primary evidence) of the broken pieces of the tempered glass panes and therefore it was impossible to examine the origin of failure or the fracture pattern (Fig. 6). Secondly, as the balustrade contractor who designed, manufactured and installed the works had ceased trading, very little "secondary evidence" had survived and only a limited number of asbuilt drawings, method statements and operation and maintenance manuals were kept by the client. The case had, therefore, to be analysed on the basis of circumstantial evidence only and with the existing unbroken glass balustrades as a principal reference.

Fig. 6: Status of the glass balustrade when the consulting engineers arrived on site

impact loads (overloading), spontaneous failure due to inclusions (possibly nickel sulphide, NiS) or excessive floor deflections. The first two possible causes represent common causes of failure in glass balustrades, particularly those built in the 1980s. The third cause is not a common cause of failure in balustrades; however, in this instance the relatively long span of the pedestrian bridge might have triggered this mode of failure.

The two remaining possibilities, overloading and NiS inclusion, could both have caused the failure. Failure induced by inclusions causes a characteristic fracture pattern (see *Fig. 4e*); however, the unavailability of glass fragments meant that the fracture pattern could not be analysed and the actual cause of failure could not be determined directly.

that deliberate damage was unlikely and that the possibility that two panels had been accidentally overloaded was improbable. In the absence of further evidence, it was therefore established that the most likely cause of failure was inclusions on the glass, specifically nickel sulphide. The client was also advised that in such a scenario there were no technical grounds to find the main contractor liable as the monolithic fully tempered glass procured in the 1980s was considered "safe" by contemporary standards and appropriate for a balustrade application at the time of the construction. Furthermore, the problems caused by nickel sulphide inclusions in tempered glass were not fully recognized by any standard at that time. The problems of spontaneous failure due to NiS inclusions was not properly addressed by the industry until recently with the introduction of heat soak testing to EN 14179:2005 [27, 28].

The above risks persuaded the client to replace all the existing monolithic tempered glass panes with laminated glass (two sheets of heat-strengthened glass bonded by 1,52 mm of PVB) as well as the steel fixings and bolts. These works, including a series of impact tests to EN 12600 [29], were carried out at the client's expense and under supervision of the consulting engineers (*Fig.* 7).

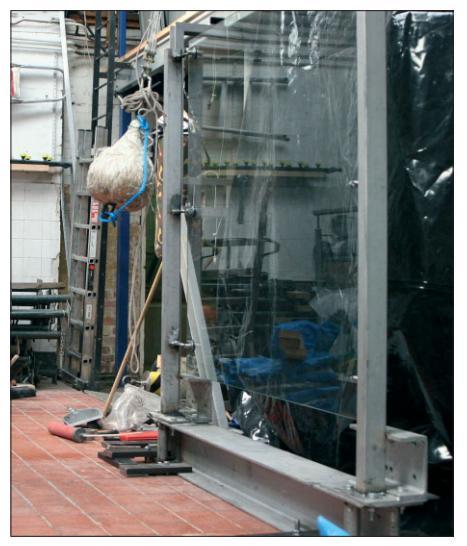
Fig. 7: Impact testing of a prototype of the new glass installation
